Traffic / Mobility issue in Silver Springs Community

This document presents all the traffic and mobility issues identified by the Silver Springs Community Association (SSCA). This list may not be exhaustive as some area of concerns may have been missed.

Issued: August 25th 2020

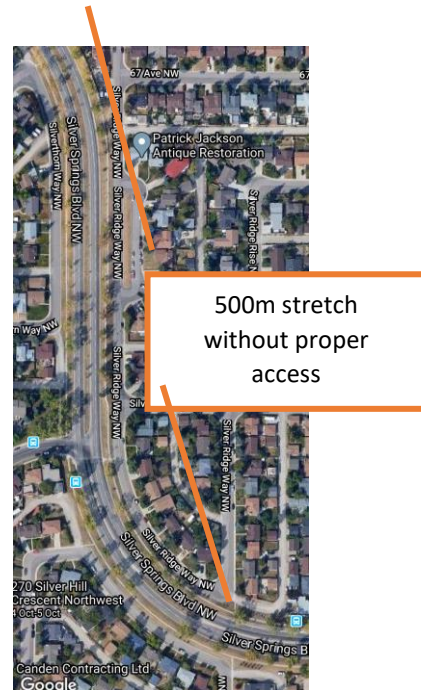
Example of one of the long stretch without proper access to the sidewalk from the side street

Add sidewalk access point for low mobility resident.

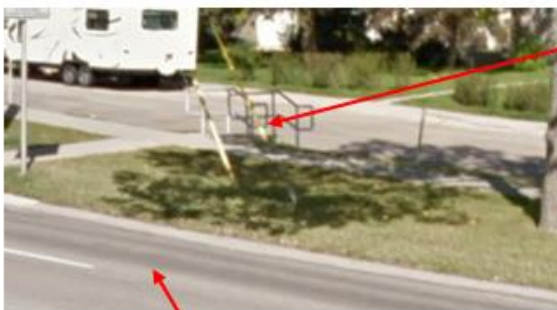
Stairs leading from Silver Ridge Way to sidewalk along Silver Springs Blvd.

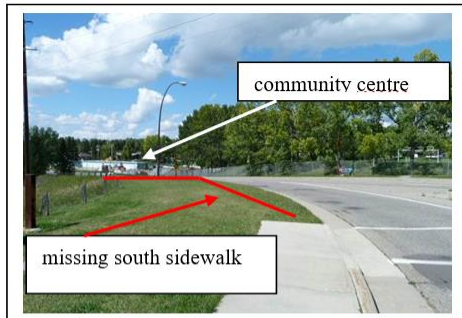
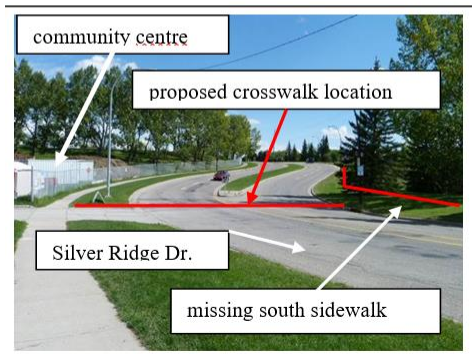
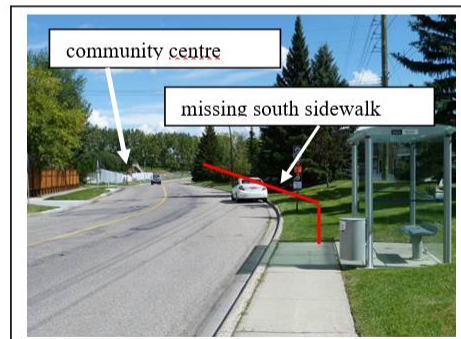
There is no sidewalk along the south side of Silver Ridge Drive between Silver Springs Blvd. and Silver Crest Dr. (east). The absence of proper sidewalks in this area limits pedestrian access to Bowmont Park, the transit bus stop on the west side of Silver Springs Blvd as well as the Silver Springs Community Centre. There is also a need to install a crosswalk to the Silver Springs Community Centre in the vicinity of the driveway to the centre. Silver Springs Preschool and the after school care (SOKO) operating from the community centre, access Bowmont park very frequently. A crosswalk will allow to bypass the busy Silver Springs Blvd./Silver Springs Gate signalized intersection to access the community Centre. It will also be beneficial to pedestrians living along or south of 54 Avenue.

Missing sidewalk looking northwest

Missing sidewalk looking southeast

Missing sidewalk looking east near Silver Crest Dr.

Construct a continuous concrete sidewalk along the south side of Silver Ridge Drive between Silver Springs Blvd. and Silver Crest Drive (east).

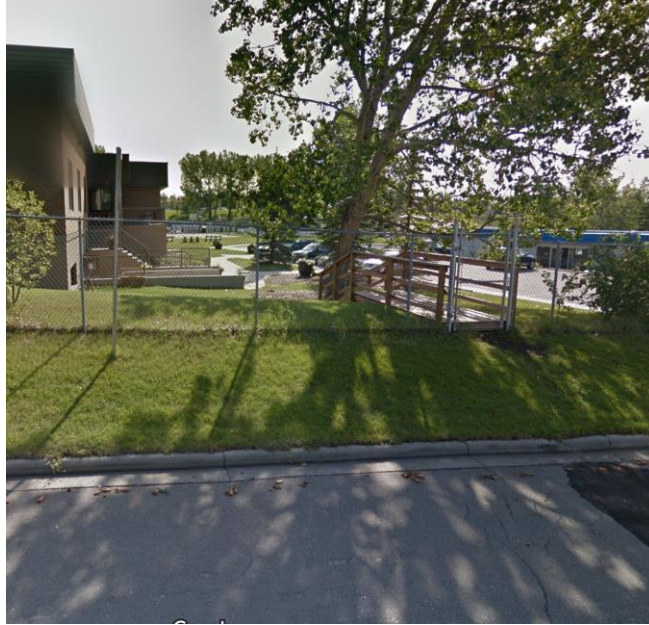
There is also a pedestrian access ramp west of the community center that was built to add access option to the community center from Silver Ridge Close (see figure below). This has been a very popular access route as it avoids the need for pedestrian to travel up to the vehicle access point when coming from the west on Silver Ridge Dr. Unfortunately the city as instructed the SSCA to close this access point as no side walk exists along Silver Ridge Close (community centre side).

View of the locked pedestrian access point on the west side of the community center, from Silver Springs Close.

Re-evaluate the closure of the pedestrian access point to the west side of the community centre.

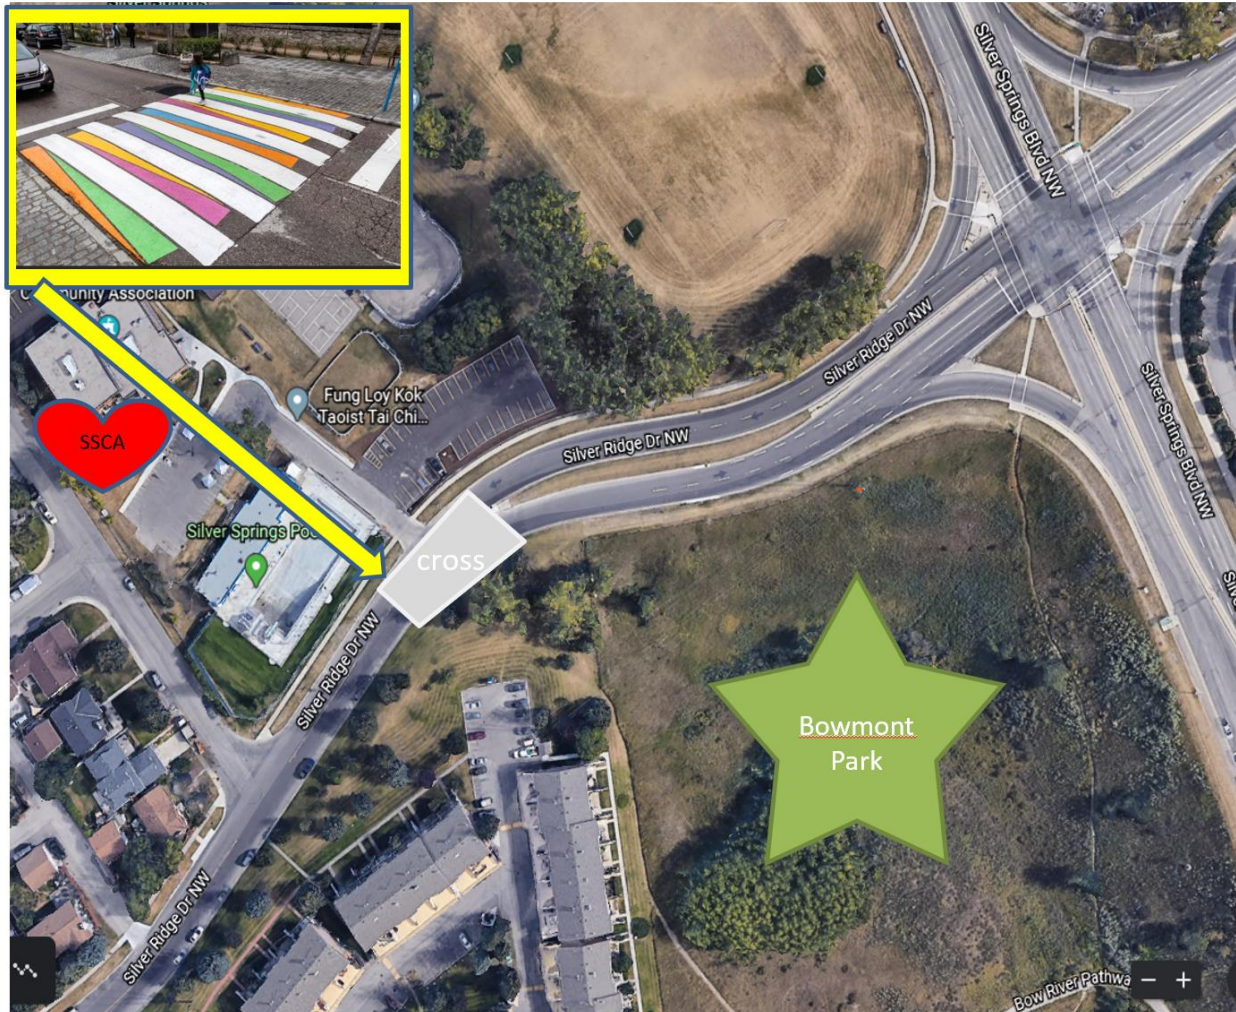
Suggestion for a large crosswalk in front of the community center

Place a crosswalk on Silver Ridge Dr. in front of the community centre along with some traffic calming curbs. This could take the form of a large painted area promoting speed reduction as shown on the figure below

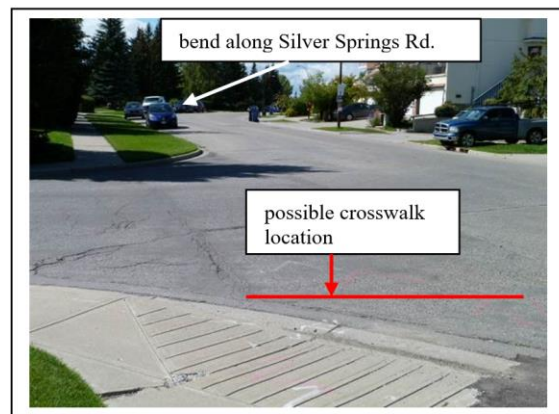
Silver Springs Rd. is an important east/west roadway connecting Nose Hill Drive to Silver Springs Blvd. The road is one lane per direction with on-street parking on both sides. There is a mixture of multi-family and single family homes along this road with many of the homes having driveways connecting directly onto Silver Springs Rd. The road is used by Calgary Transit and has bus stops on both sides of the road. Silver Valley Dr. provides access to all the residences located south of Silver Springs Rd. between Nose Hill Drive to the west and Bowmont Park to the east. Full-grown trees and on-street parking limits the ability of motorists to see pedestrians crossing Silver Springs Rd. at this "T intersection.

Silver Springs Rd. looking east

Silver Springs Rd. Looking west

Consider constructing a crosswalk with curb extensions (if space is available) at this intersection to improve the safety of pedestrians crossing this roadway.

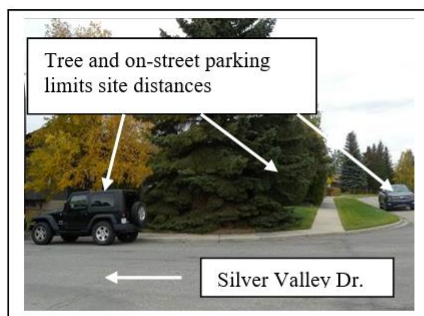
Silver Valley Dr. is used to access all the homes south of Silver Springs Rd. between Nose Hill Dr. and Bowmont Park. A stop sign is located on Silver Valley Dr. for northbound traffic. Site lines are restricted at this intersection by on-street parking and the fir tree in the southwest quadrant of the intersection.

Pedestrians as well as motorists have difficulty seeing oncoming traffic due to restricted visibility at this intersection. Northbound vehicles on Silver Valley Dr. need to extend into Silver Springs Rd. right-of-way in order to see oncoming traffic. This can block the road space used by pedestrians to cross Silver Valley Dr. It also restricts the visibility of pedestrians and vehicles at this intersection. Vehicle tend to speed on Silver Springs Rd which does not help the situation.

Fir tree & on-street parking restricts site lines

Determine if the fir tree is on city or private land and take appropriate action to improve the visibility of pedestrians and vehicular traffic in the southwest quadrant of the intersection.

Review on-street parking to see if there are ways to improve the visibility of pedestrians and motorists at this intersection.

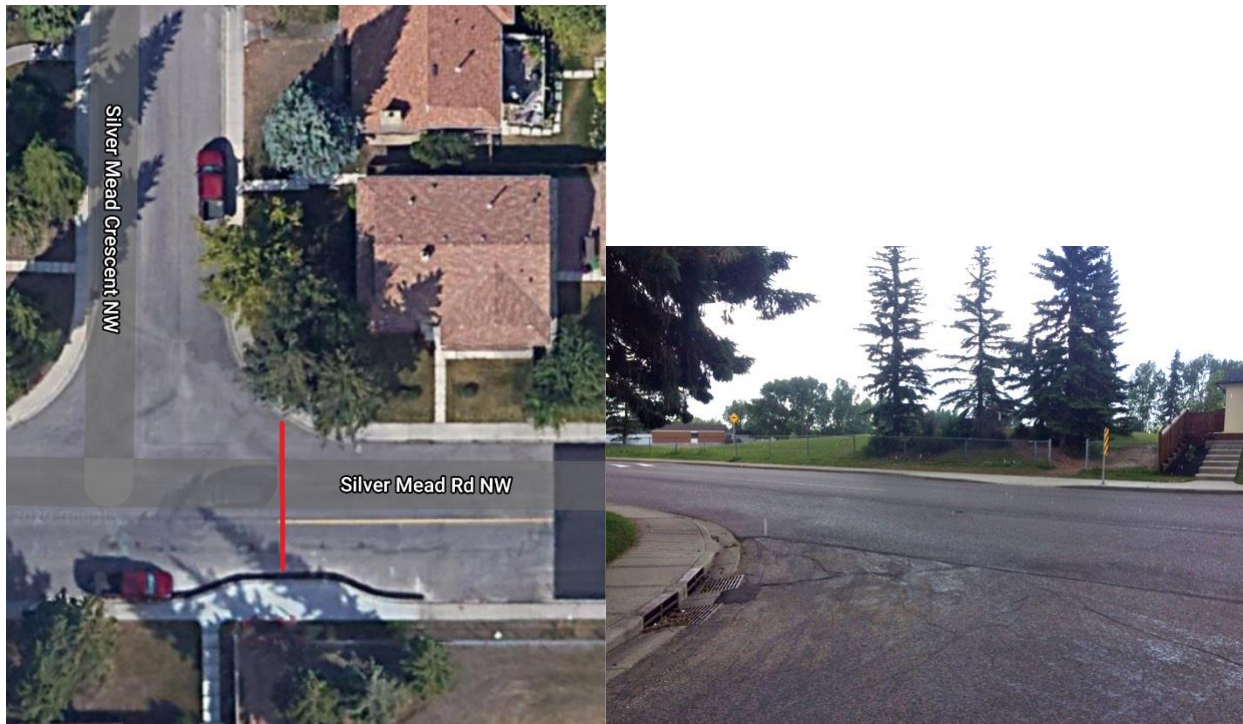
Silver Mead Rd is a 30km/hr zone at that location as it is next to a playground and a school. The crosswalk in front of Silver Springs School (east of Silver Mead Crescent) is marked (zebra mark) however there is no marking at Silver Mead Rd despite the fact that it is a high-volume crossing. At this location there is an opening to the chain link fence to access a very popular playground and it is also used by pedestrian to access the community center from the north. In addition, this is the route used by the children traveling between SOKO (before/after care program) and St Sylvester School 3 times per day.

Left: Areal view of the intersection, right: view of the intersection looking South from Silver Mead Crescent.

Mark the pedestrian crossing with zebra marks as the other crosswalk in front of Silver Springs School.

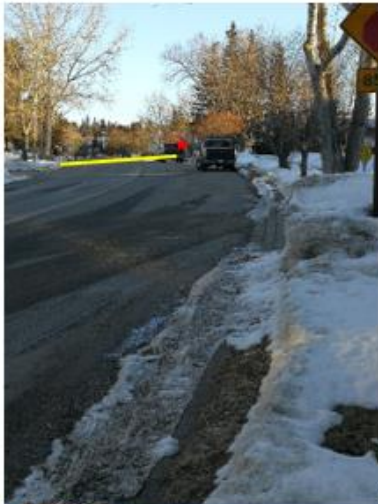
The crosswalk to cross Silver Springs Blvd. at Silver Ridge Dr. is on the east side of the intersection. Individuals walking east along the south side of Silver Springs Blvd. (for example, to access St. Sylvester School), must cross Silver Ridge Dr. to access the crosswalk to cross the Blvd. Visibility for drivers heading north on Silver Ridge Dr., as they approach the intersection is poor due to topography of the road (driving uphill) and vehicles parked on the east side of Silver Ridge Dr. There is no marked crosswalk on Silver Ridge Dr. and no signage indicating that drivers are approaching an intersection. The playground/ school zone for St. Sylvester begins just before drivers reach the intersection, when many are still transitioning to 30km/ hr from 50km/ hr.

The view driving north on Silver Ridge Dr. approaching the crosswalk at Silver Springs Blvd. from 85 meters south of the intersection. The stop sign is indicated by the red star and the crossing indicated by the yellow line.

Adding a marked crosswalk across Silver Ridge Drive at Silver Springs Blvd. on the south side of the intersection and changing the current signage to notify drivers of the crossing.

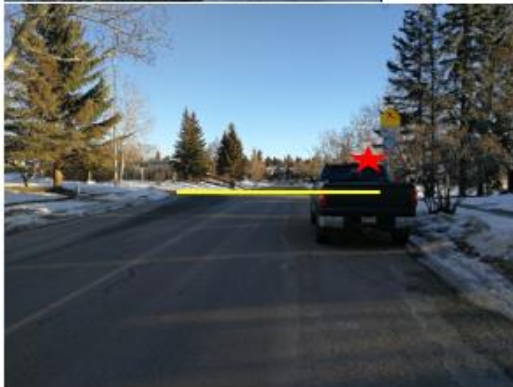
Approaching the crossing on Silver Ridge Dr. at Silver Springs Blvd. The stop sign (in front of the truck, indicated by the red star) and first part of the intersection (marked with the yellow line) is blocked from view by the parked truck.

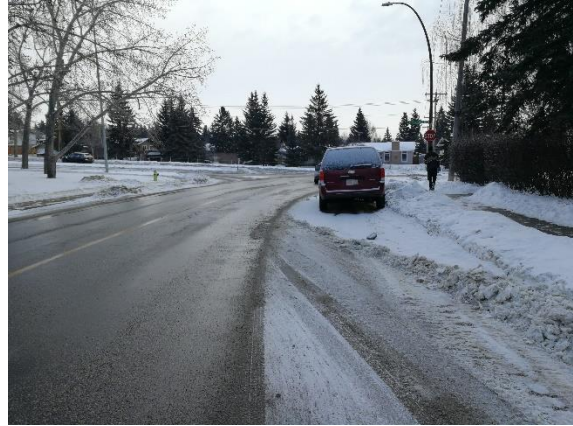
There is no marked crosswalk on Silver Springs Road at Silver Springs Blvd. and visibility for traffic coming east from Silver Springs Road onto Silver Springs Blvd. is poor due to there being a slight bend in the road as vehicles approach the intersection, and vehicles parked along the south side of Silver Springs Road. Several individuals shared stories of being cut-off by vehicles while crossing Silver Springs Road or drivers approaching the intersection at a high speed. This is of particular concern since this is the path children tend to use when walking to schools in the community

Approaching Silver Springs Blvd. from east-bound Silver Springs Road with a vehicle parked on the south side of the road.

Reducing speed on Silver Springs Road, add a marked crosswalk at the intersection and signage warning drivers of approaching crosswalk.

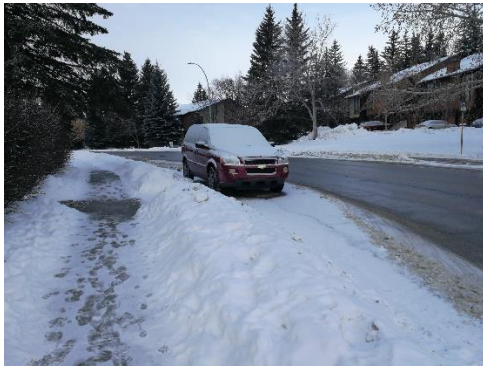
Looking west along Silver Springs Road from the south corner of the intersection with Silver Springs Blvd.

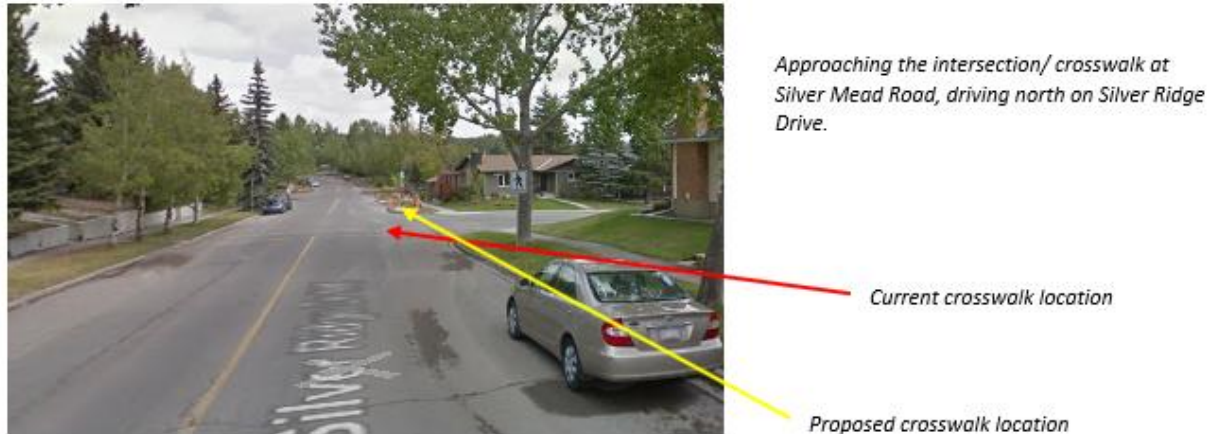
There is a t-intersection where Silver Mead Road ends at Silver Ridge Drive, with a marked crosswalk, across Silver Ridge Drive to access Silver Mead Road. The crosswalk is on the south side of the intersection and cars travelling north on Silver Ridge Drive crest a hill as they approach the intersection. They have limited visibility of the crosswalk and several residents have stated that they have experienced near misses while in the crosswalk, due to drivers at or above the speed limit cresting the hill and having little time to stop. There are often vehicles parked on the east side of Silver Ridge Drive potentially restricting the driver's ability to see pedestrians in the crosswalk.

Moving the crosswalk to the north side of the intersection (there are cut-outs on both corners of Silver Mead Road). This will give motorists a greater distance to see pedestrians when they are driving northbound down the hill. Moving the signage further away from the crosswalk (south along the road), giving the drivers more notice of the approaching intersection. In addition traffic calming curbs could be added to improve pedestrian safety but also help the speeding issue on Silver Ridge Dr.

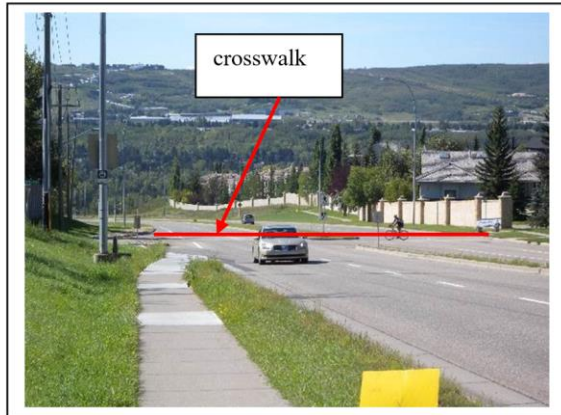
Nose Hill Dr. is a major roadway separating Silver Springs and Scenic Acres communities. The intersection of Nose Hill Dr. and Silver Springs Rd. is unsignalized. There is an extensive pathway system on the west and east sides of Nose Hill Dr. used by pedestrians to access the transit stop. Cyclists and pedestrians use this crosswalk to access pathways leading into their communities as well as Bowmont Park to the south.

Nose Hill looking south towards the crosswalk

Consider installing a pedestrian activated crosswalk or traffic signal at the intersection of Nose Hill Dr. / Silver Springs Rd. so that pedestrians and cyclists can cross Nose Hill Drive safely. Until such an improvement can be carried out, consider installing the yellow crosswalk sleeves on the crosswalk signposts.

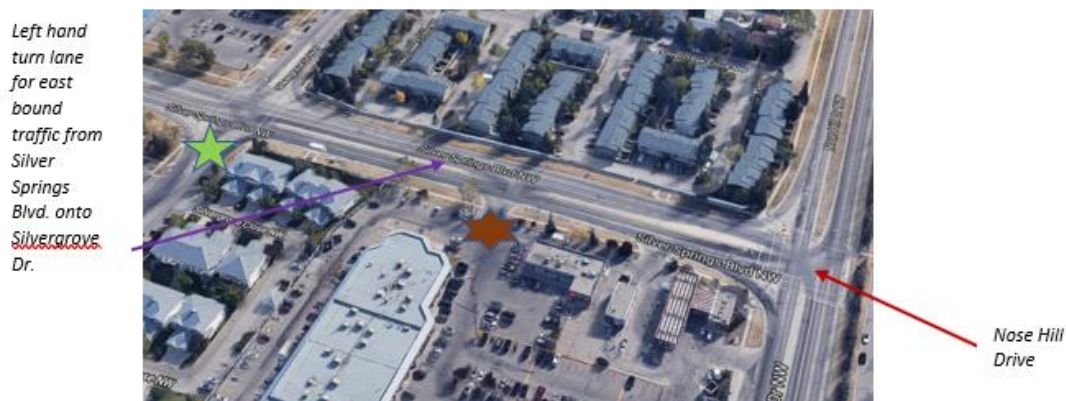
Aerial view of the exit from Spring Hill Plaza onto east-bound Silver Springs Blvd. The green star indicates Silvergrove Drive and the red, the exit from the shopping centre.

1. Consider a round about so that the left-in traffic would have to give priority to the left-out traffic.
2. Consider constructing a “pork chop island” in the median opening to separate left-in from left-out traffic. It would also provide left-out traffic with a safe place to wait for gaps in eastbound traffic. It would improve the driver’s ability to see eastbound traffic gaps.
3. Another option would be to alter the operation of the Nose Hill/Silver Springs Blvd. intersection. Can the signal timing be altered to provide less continuous flow of the left turn traffic without significantly altering the level of service of the intersection? Can the right turn exit lane be altered to reduce the ease of this movement, thereby providing more gaps in eastbound traffic?

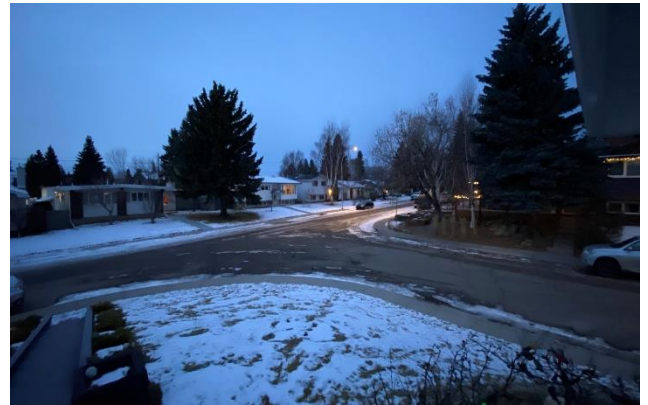
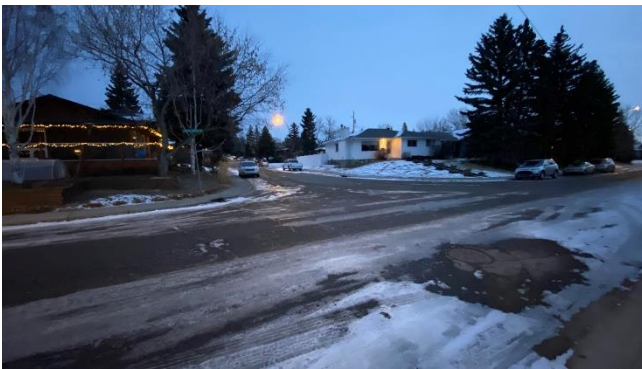
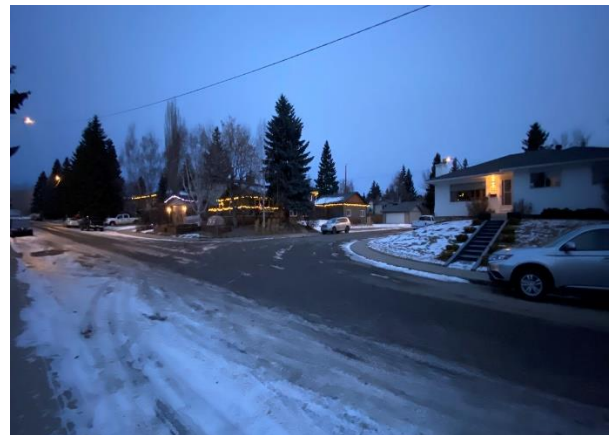
Aerial view (Google Map)

View from NE corner

View from Silver Brook Drive towards NE corner

View from Silver Brook Drive towards NW corner

This is an uncontrolled intersection without a yield or stop sign. The large sweeping NE corner of the intersection allows vehicles to come around the corner without slowing down. This is observed for vehicles driving South on Silver Brook Way and taking a left turn to go West on Silver Brook Dr. It is also the case for vehicles traveling West on Silver Brook Dr. and turning right on Silver Brook Way. Fast traffic is also observed for vehicles turning West on Silver Brook Dr coming from Silver Brook Way.

- Placing low impact speed bumps on Silver Brook Way AND Silver Brook Dr (east side of the intersection)
- Placing a stop or yield sign on a temporary traffic calming curb located between the two lanes of traffic on Silver Brook Way. This would force car not to cut the corner at excessive speed.
- Placing temporary traffic calming curb on the NW corner of the intersection.
- Add signalisation warning drivers of a high impact intersection.

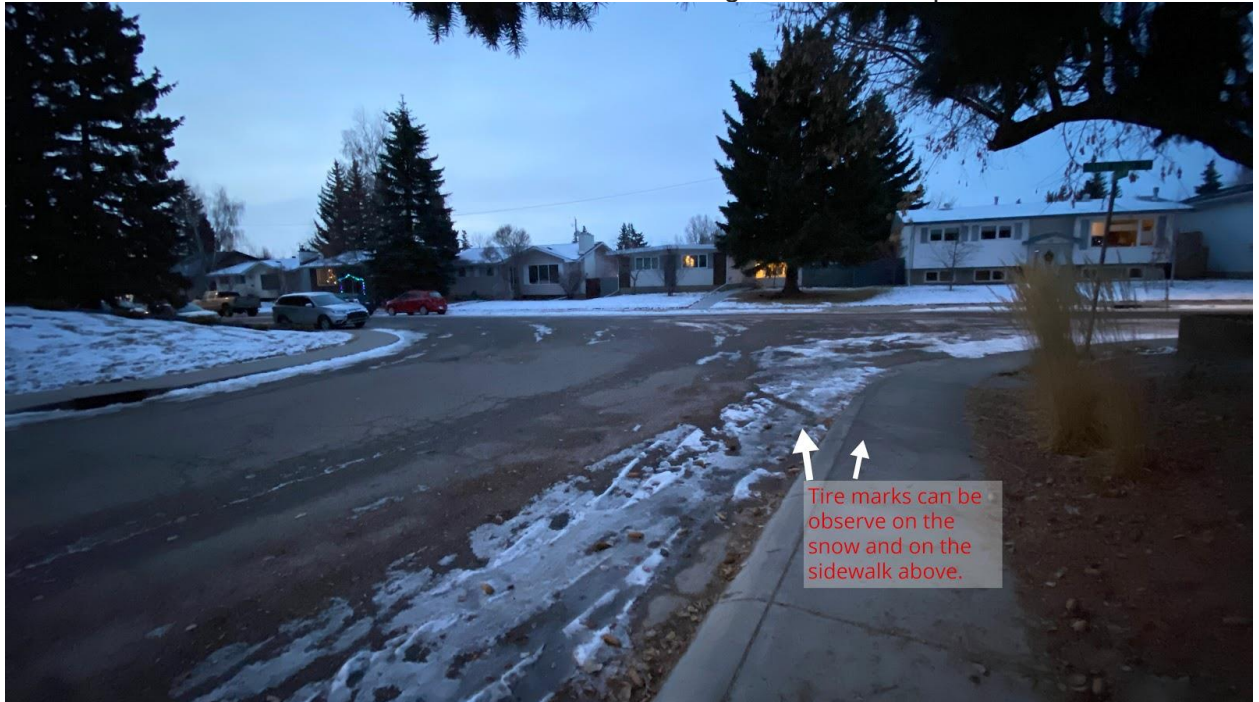
- December 15, 2020: A car parked on Silver Brook Dr. was hit by a vehicle traveling from Silver Brook Way and taking the turn to Eastbound Silver Brook Drive.
- Between October and December of 2020 a total of three other vehicles got hit from vehicles losing control at this intersection.
- In December 2020 skid marks were observed up over the sidewalk and in the yard of the house on the NW corner from a vehicle unable to manage the turn. See picture below.

All of those incidents seem to be the result of excessive speed at the intersection. The issue is exacerbated in the winter when the intersection may be slippery. Given the nature and number of incidents we are greatly concerned that a pedestrian or cyclist will be injured on day.

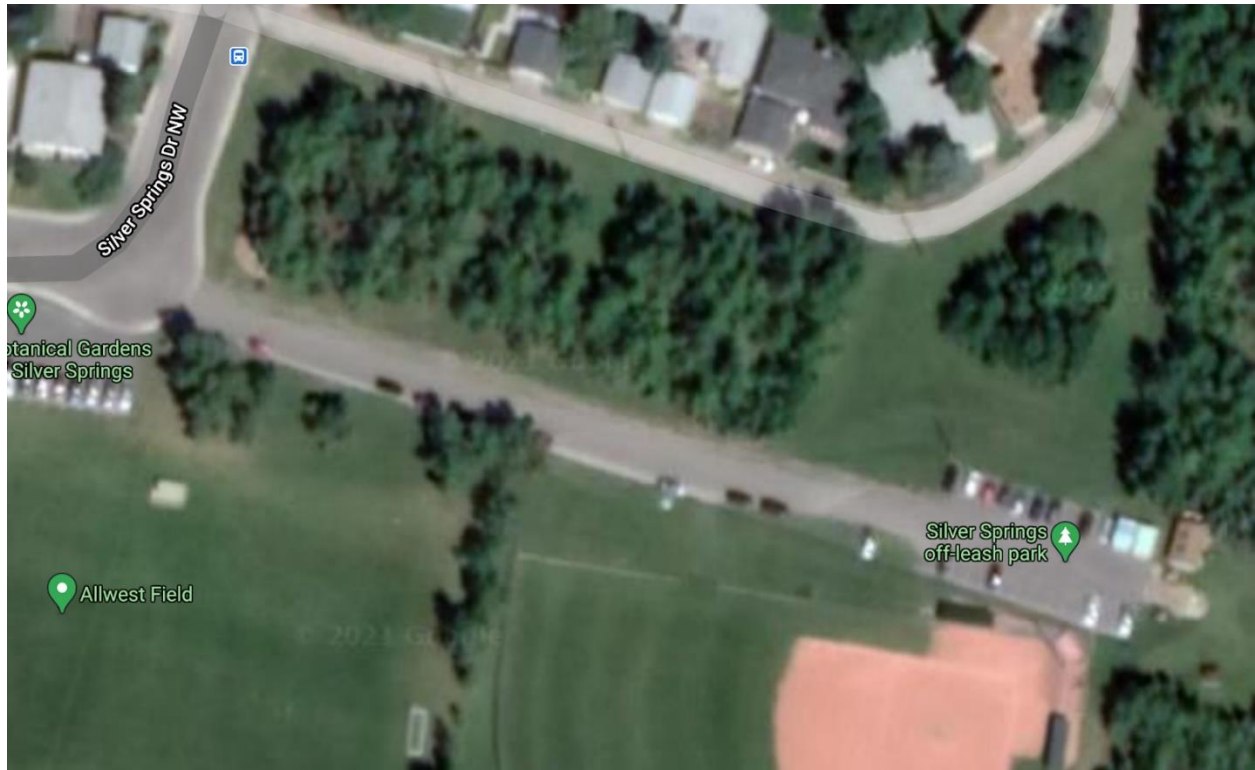
The access road to the Parking Lot at the Botanical Garden and Off Leash Area sees a lot of car, cyclists and pedestrian. Historically it has been a gravel road but it has been repaved recently. Since then, drivers tend to drive too fast for the conditions. The topology of the parking space seems also challenging.

Figure: View of access road to the botanical garden / off leash area parking lot

Study the situation and implement solution that could improve the parking topology and also limit vehicle speed.P
